DUTCH FORK DAM

NDI I.D. NO: PA-490

PHASE I INSPECTION REPORT
NATIONAL DAM INSPECTION PROGRAM

D'APPOLONIA CONSULTING ENGINEERS
10 DUFF ROAD
PITTSBURGH, PA. 15235
JANUARY 1979

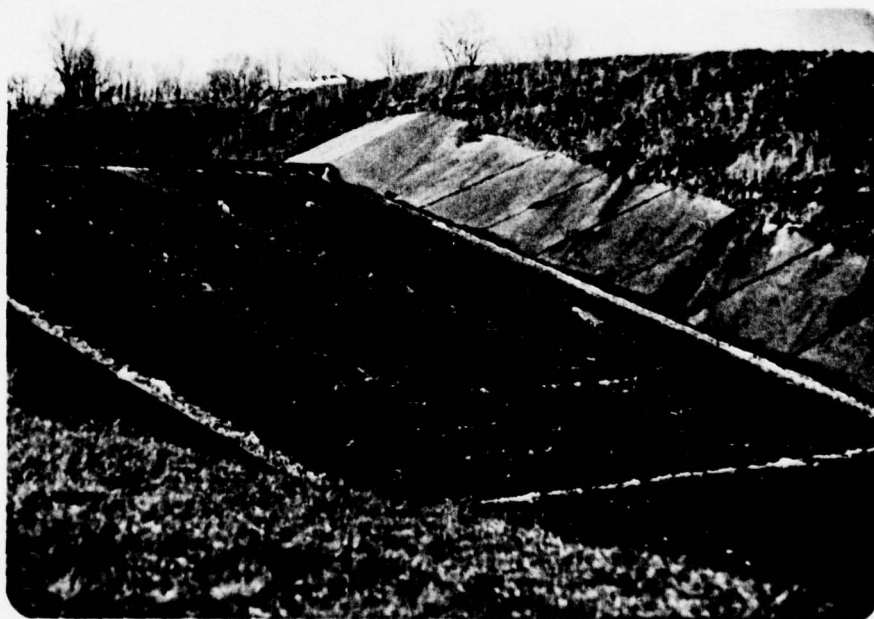
Photograph No. 2
Spillway discharge channel.

c. Appurtenant Structures. The spillway and outlet works were examined for deterioration or other signs of distress and obstructions that would limit flow. In general, the structures were found to be in good condition. Several structural cracks were observed in the lower half of the spillway discharge channel. However, due to the flow in

the spillway, these cracks could not be closely examined. The visible portions of the control tower and the outlet conduit were found to be in good condition.

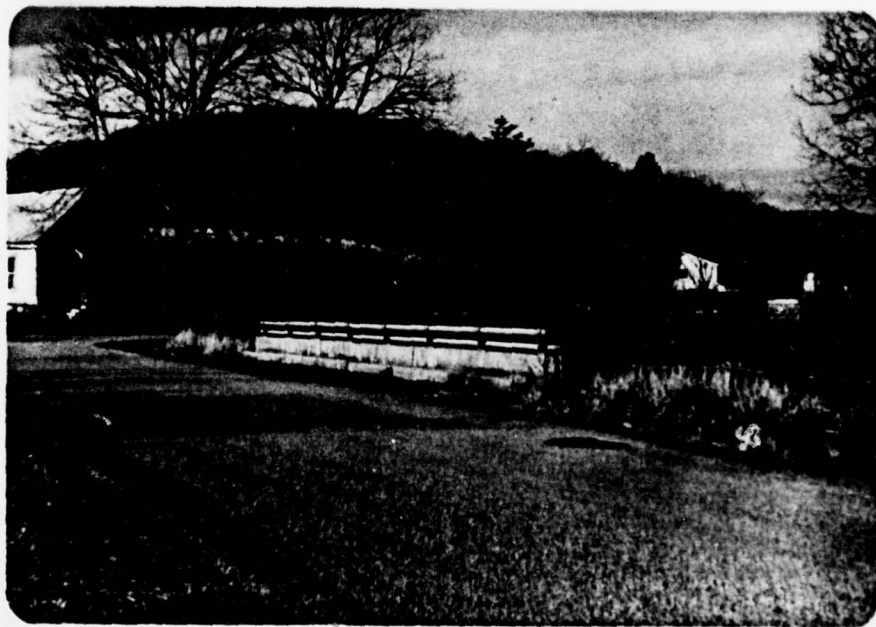
Photograph No. 6
Homes along Dutch Fork (approximately one mile
downstream from dam).

Downstream from the dam, Dutch Fork generally flows north, meandering through a 200- to 300-foot valley, and joins Buffalo Creek 3-1/2 miles downstream from the dam. In this reach, one mobile home and five permanent homes are considered to be within the flood plain of Dutch Fork Dam. It is estimated that failure of the dam would cause more than a few lives lost.
